PERTH AND KINROSS COUNCIL**Environment Committee****12 November 2014****Blairgowrie, Oakbank Road Landslip****Report by the Executive Director (Environment)****PURPOSE OF REPORT**

Landslip Options Report

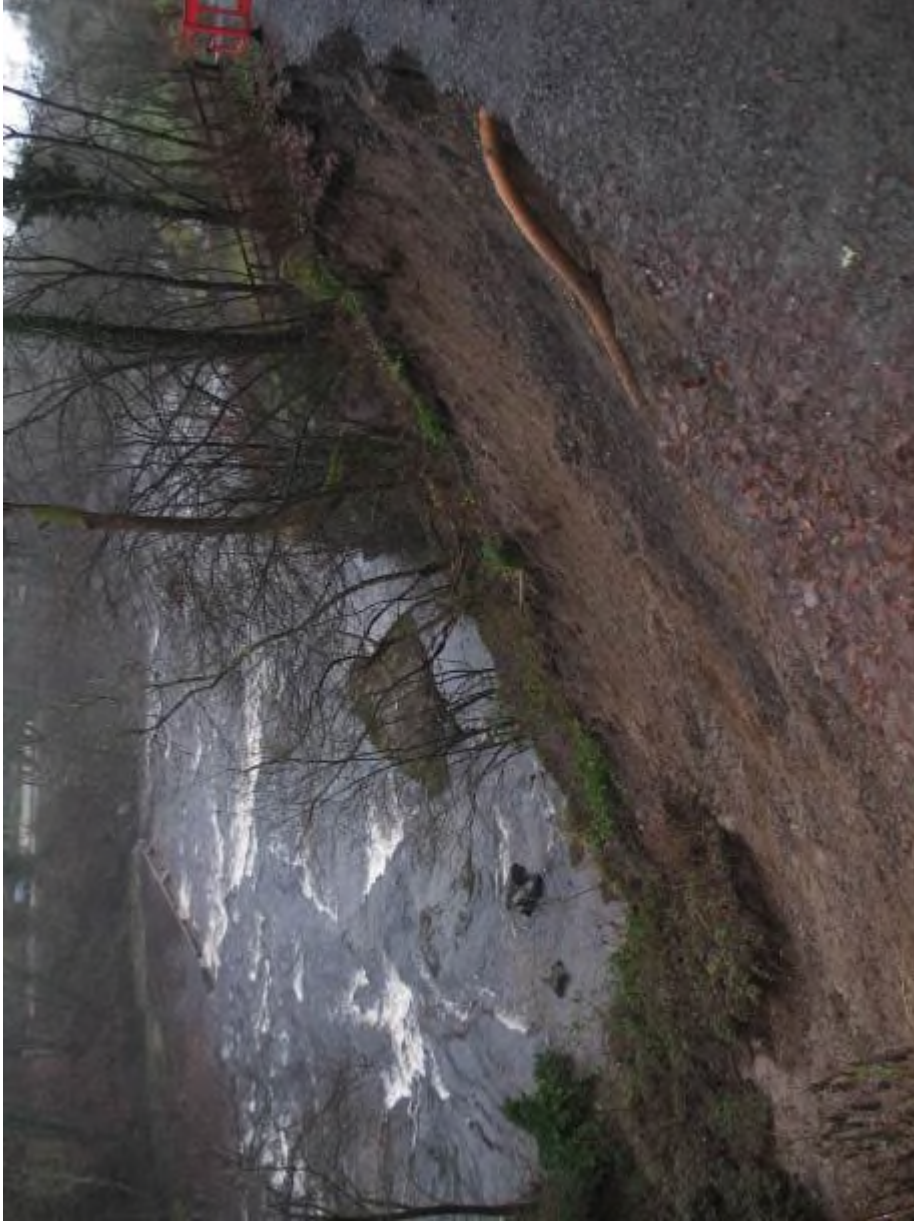
2012 Landslip Damage

- 1.2 A severe landslip occurred on the Oakbank Road just prior to Christmas 2012 following a period of sustained heavy rain. This saturated the embankment material and increased the river flow causing erosion to the base and subsequent collapse. A section of the track up to 1.3m wide was lost over a length of approximately 19m to a width of about 30m. An estimated 600 tonnes of material was washed down the river (Appendix 2). The edge of the track continues to erode. There has been previous movement of the slope on a 12 metre long section with partial failure of a retaining wall in 2011, further north of the 2012 landslip. There is evidence the whole area has been subject to several slippages in the past.

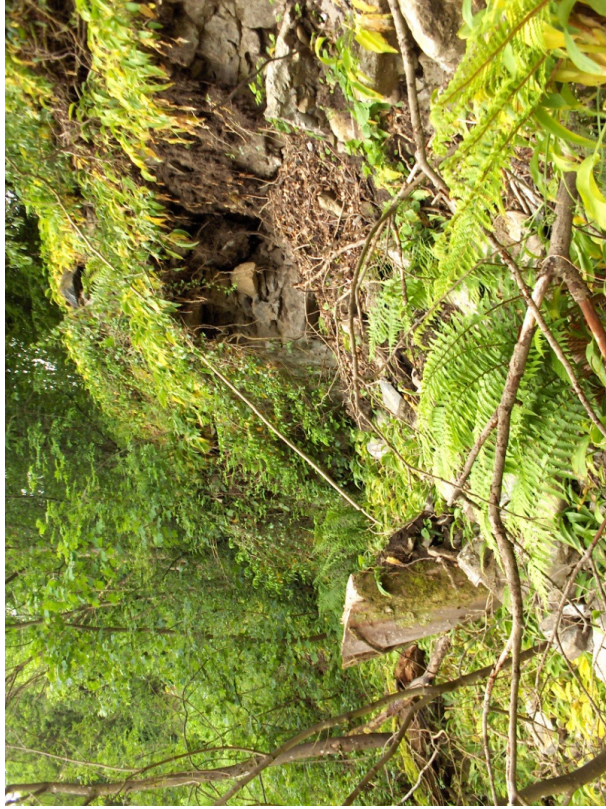
- **2011 Landslip** "The resulting slope face is currently at 1 in 1.5 (35°) and is likely to have only marginal stability and be susceptible to soil creep...A section of wall remains but it is likely to tumble at some point." p2-1

*Plate 1 - The 2011 Landslip – note masonry blocks tumbled down slope
(Photo dated 12 Jun 12)*

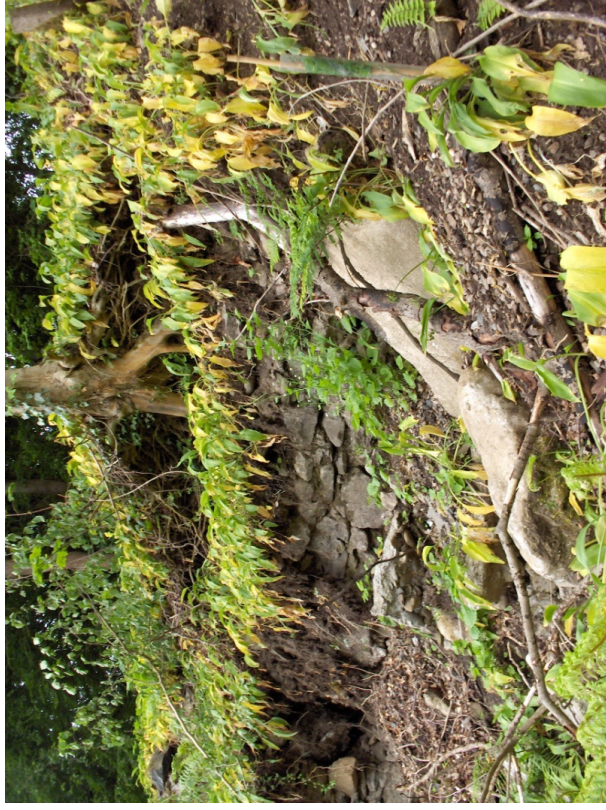
*Plate 2 - The 2011 Landslip – intact section of wall
(Photo dated 12 Jun 12)*

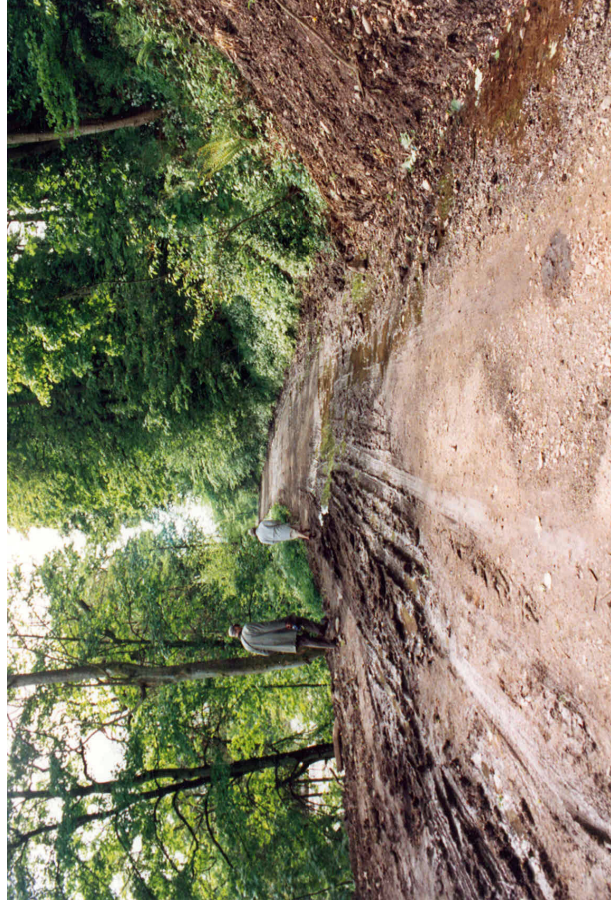
*Plate III - View North towards the 2011 Landslip
(Photo dated 12 Jun 12)*

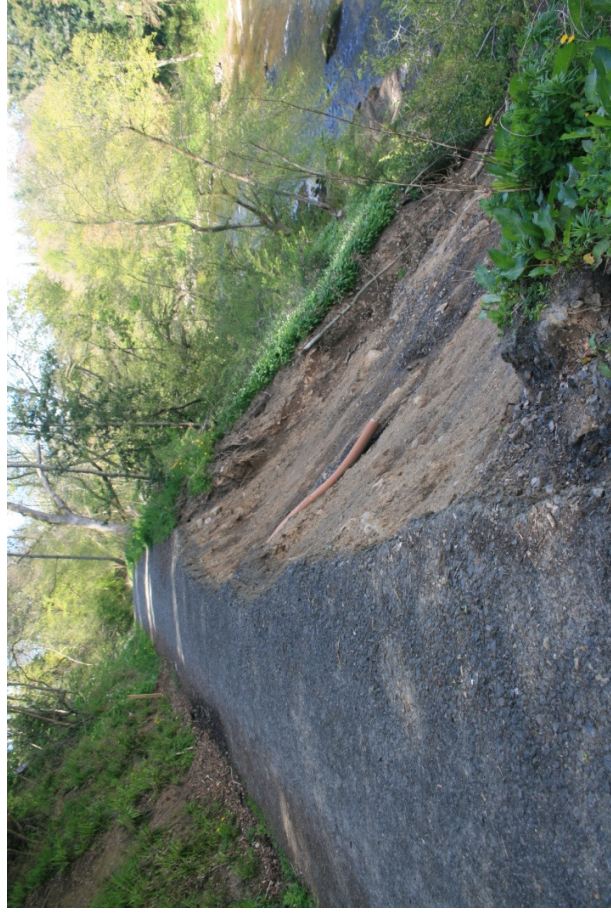
- **2012 Landslip** "The exposed soil face along the north edge of the landslide is ...an over-steepened lower slope where river erosion and landslide has removed the toe of slope. This would be a key preparatory factor in the landslide incident that was observed in December 2012, this in combination with wetting up of the materials in a period of heavy rainfall." p2-2

*Plate IV - View North over the 2012 Landslip
(Photo dated Dec 12)*

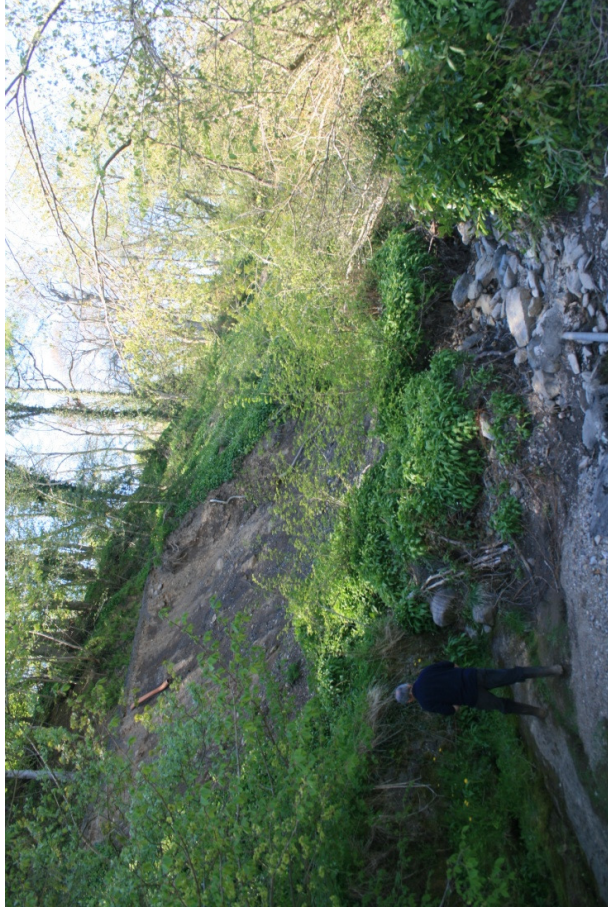
*Plate V - View from the river up to the 2012 Landslip
(Photo dated Dec 12)*

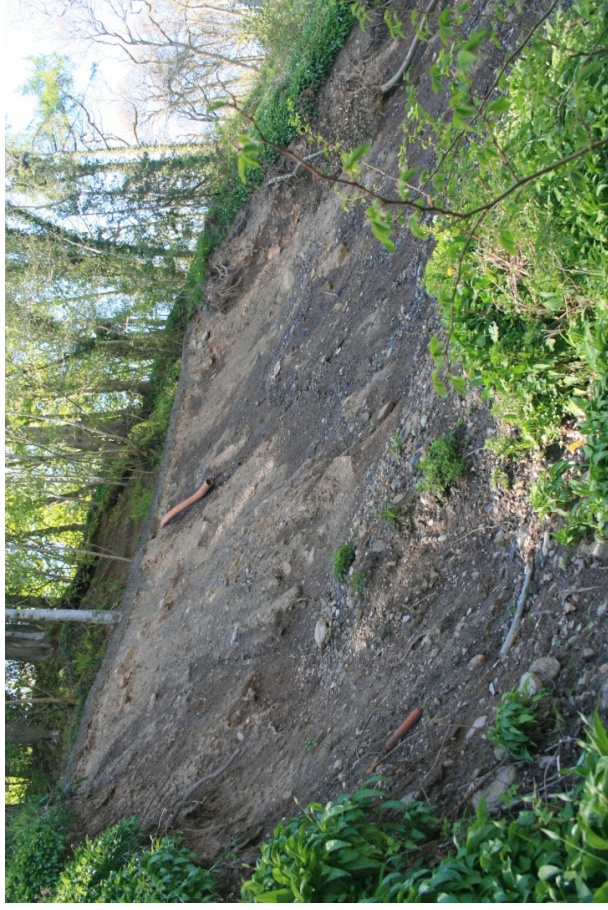
This is a shallow translational failure with some characteristics of debris flow that has spilled a slab of soil off the slope face and into the river. Coincidentally there is a scar in the slope above the road directly behind this landslip (see Plate VI). Consideration has been given to this being part of a more deep seated landslip with the observed failure being a secondary collapse of an over-steepened toe. However, the absence of lateral tears across the road to connect the two areas suggests that these features are unrelated. The depth of observed landslip is self evident as the steepness of the slope has resulted in the 'slip bowl' being fully evacuated to expose in-situ material. The exposed face is approaching 1 in 1 (42°) in the upper slope and 1 in 2 (27°) in the lower slope.

*Plate VI - View up to the 2012 Landslip – note scar in slope above the road
(Photo dated Dec 12)*

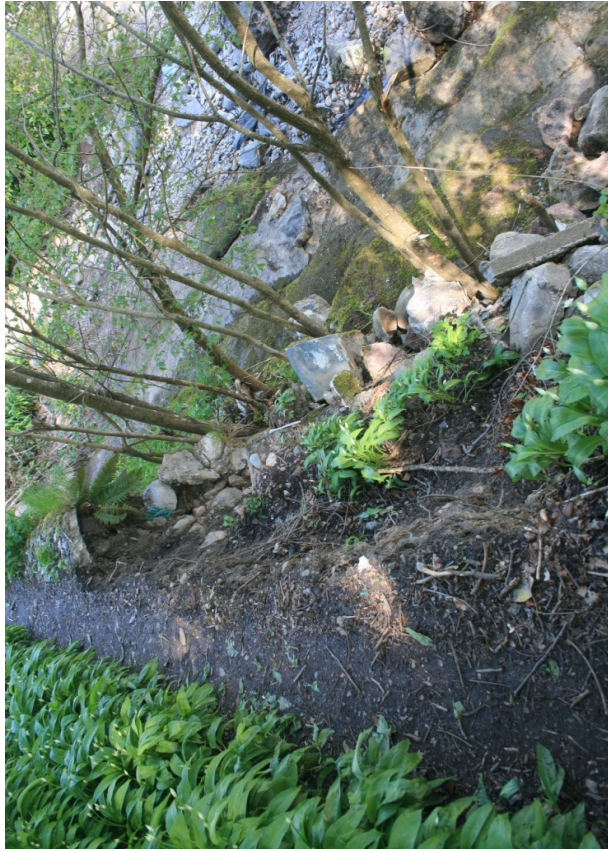
In addition to the above, we understand that a wall some 15m south of the 2012 landslip collapsed at around the same time (see Plate VII). This is some 1.5m in height and carries a narrow footpath below a wooded area and alongside the river bank. It is believed to have been constructed around the same time as the weir/ sluice/ mill lade structures. It may be that the landslide impacted directly on the wall further along, which caused vibration and collapse of this vulnerable section of masonry, but other than that the two incidents appear to be unrelated.

Plate VII - Wall collapse in the vicinity of the 2012 Landslip
(Photo dated Dec 12)

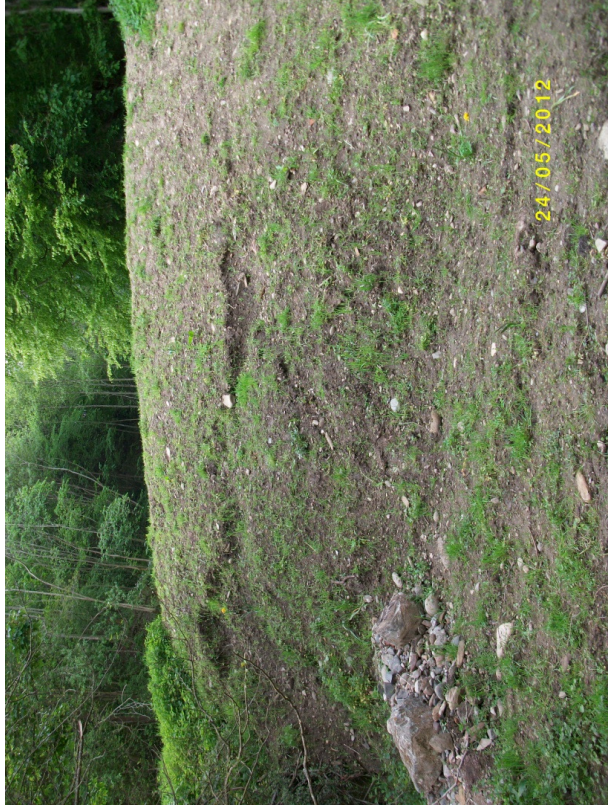
Plate VIII

- Road embankment containing Cuttle Burn Culvert that collapsed when the culvert blocked and water over-topped the embankment. This got remediated prior to 2011 (Plate VIII).
- Road embankment above the grassed amenity area, identified as Area 3 in 'Brief for WP H118 – Blairgowrie Riverside'. Proposals have been made for remediating this section of embankment.
