- 1.1. Savills are submitting a planning application, on behalf of their client, Pilkington Trust, to demolish a redundant farm steading and replace with new agricultural buildings at Methven Castle, Methven, Perth, PH1 1SU.

- 1.2. To be clear, the planning application is to demolish the steading, which is currently falling into a state of disrepair, and replace with three modern agricultural sheds, including a grain store, cattle shed and general-purpose building. These sheds are required to meet operational needs of the farm tenant.

Structural Condition Assessment – Methven Castle Steading

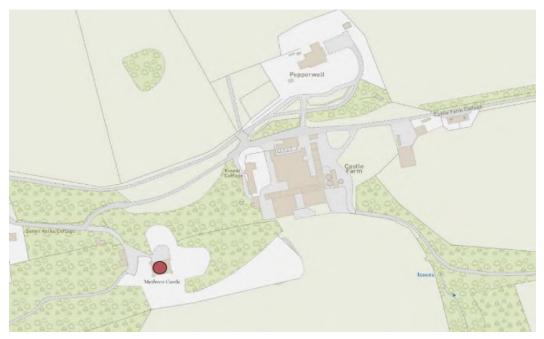
Figure 2 - Pastmap extract showing listing designation

- 2.9. We have undertaken a desktop analysis of constraints on the site and our key findings are summarised below:
 - Cultural Heritage: the steading is not listed however in-curtilage impacts are possible on the setting of Methven Castle. Figure 2 shows the listing designation covering the Castle only. We hope the information within this submission and the 3D visualisations in particular demonstrate that the proposal is low impact in visual terms and does not have an impact on Methven Castle. The steading is located within the Methven Castle Garden and Designed Landscape designation.

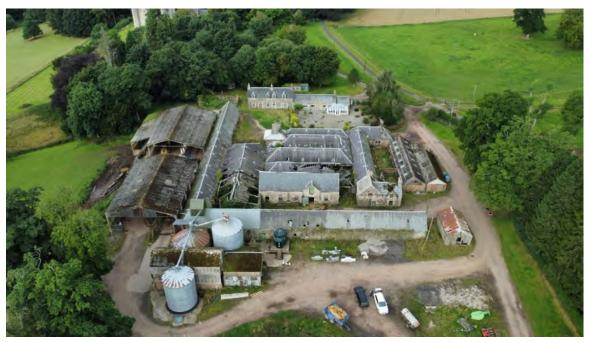
Figure 3 - Aerial View of Steading

- 2.10. Figure 3 is an aerial view of the site and it demonstrates the unsafe and dilapidated condition of the majority of the buildings. To be clear, the two large sheds to the south of steading are to be retained. These sheds are shown shaded grey on Figure 4.

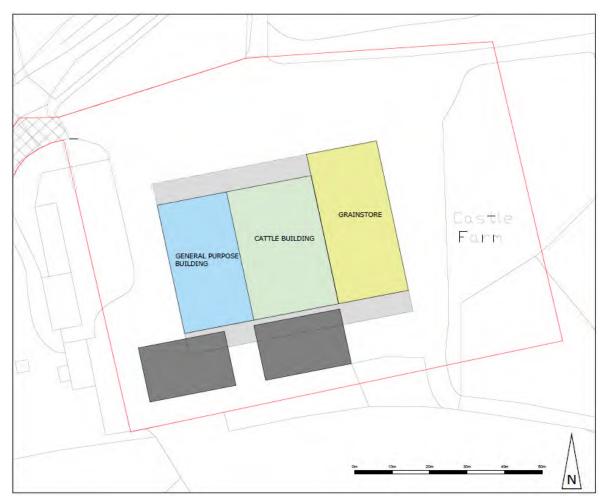
Figure 5 – Proposed Block Plan

3.1. As discussed, the planning application is to demolish the steading and replace with modern agricultural buildings. The new agricultural buildings would comprise one grain store, one cattle building and a general-purpose building. As mentioned, the two large, non-traditional agricultural sheds to the south of the site (shaded grey) would be retained. Please see the proposed block plan below.

3.2. In terms of shed design, the proposed grain store is approximately 36m x 19m, the proposed cattle shed is approximately 36m x 23m and the proposed general-purpose shed is approximately 36m x 18m. The grain store has two roller doors on the north and south elevations. The cattle shed has sliding doors on both sides accessing a 4.5m feed passage on to four pens. The general purpose shed simply has sliding doors on both sides. Please refer to full suite of drawings including location plan, existing block plan, demolition block plan, proposed block plan, proposed floor plan, proposed elevations, proposals portal section and proposed photo montages (visualisations) that accompany this application.

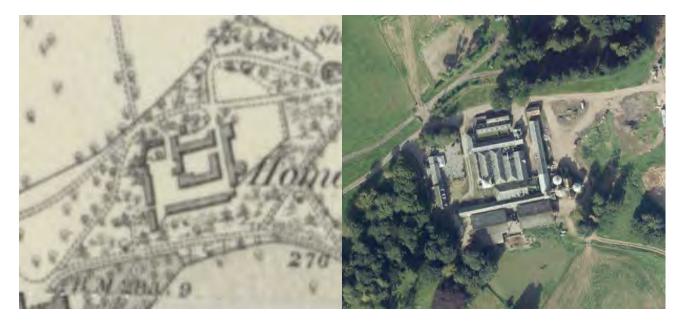
Fig 01: Excerpt from the National Library of Scotland; 1843 - 1882

A search through the National Library of Scotland's historic map archives has revealed that the steading grouping has undergone a number of changes over the years. This first excerpt appears to show Methven Castle steadings, as a square shaped structure, with detached buildings to the South, West and Northwest of the main block respectively. Buildings 01, 05, 06, 07, 09, 14 and 15 have not yet been constructed. Buildings to the Northwest corner adjacent to the NW cottage no longer exist.

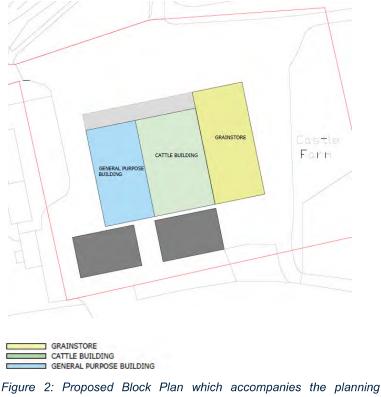
The proposed block plan shown in Figure 2 below helps demonstrate the proposed plans and requirements on the site and the two sheds shaded in grey being retained for straw storage to be used for the cattle enterprise.

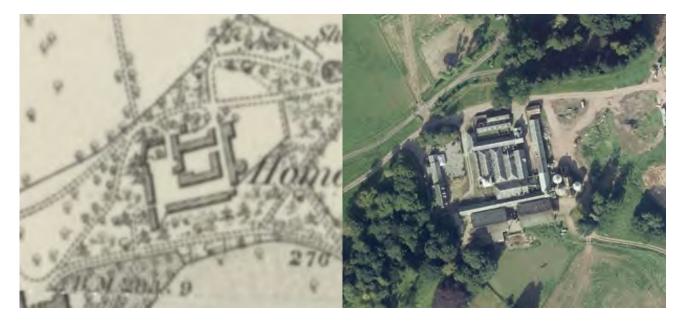
Fig 01: Excerpt from the National Library of Scotland; 1843 - 1882

A search through the National Library of Scotland's historic map archives has revealed that the steading grouping has undergone a number of changes over the years. This first excerpt appears to show Methven Castle steadings, as a square shaped structure, with detached buildings to the South, West and Northwest of the main block respectively. Buildings 01, 05, 06, 07, 09, 14 and 15 have not yet been constructed. Buildings to the Northwest corner adjacent to the NW cottage no longer exist.

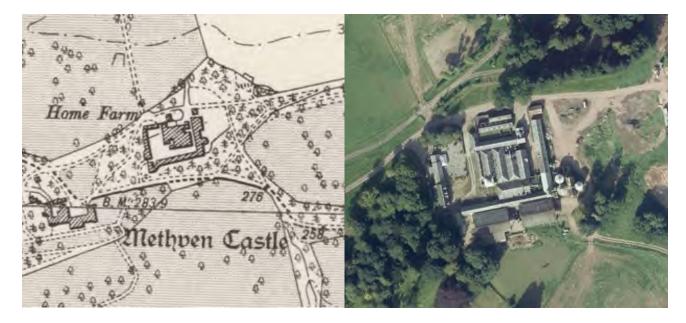
Fig 02: Excerpt from the National Library of Scotland; 1900s

By the 1900s, it appears that buildings 05, 06, 07 have been added to in-fill the central space between buildings 04 and 08. Building 15 has also been constructed. Building 11 appears to have a larger footprint toward the most northern third of the building than currently exists.

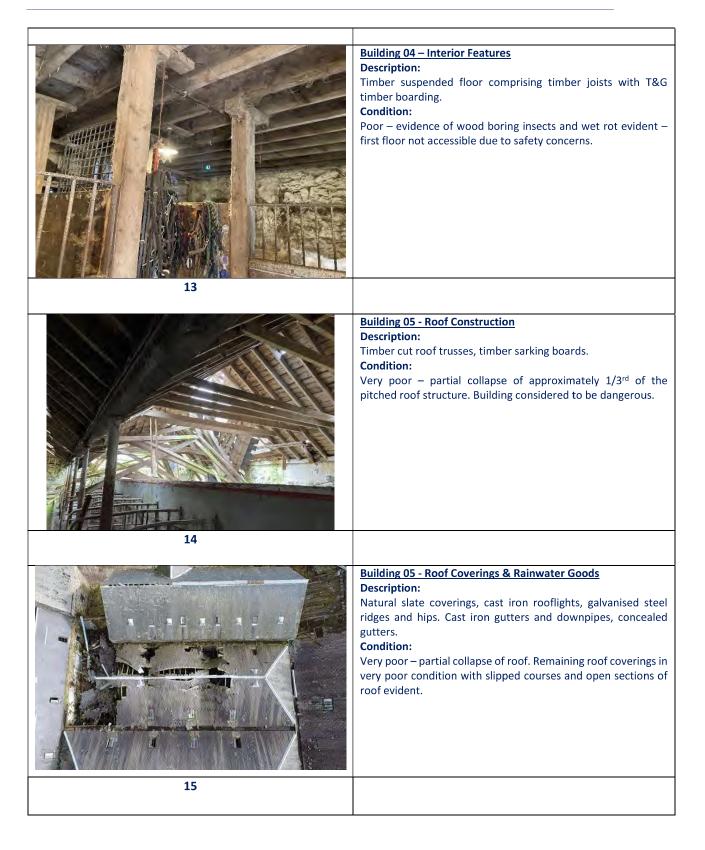
<image/> <page-footer></page-footer>	Building 05 – External Walls Description: Solid coursed rubble stone masonry walls (shared with buildings 03 and 04), Metal beams and columns (shared with buildings 06 and 09). Condition: Poor – undulations in beams evident, moderate corrosion to columns.
	Building 06, 07 - Roof Construction Description: Timber cut roof trusses, timber sarking boards. Condition: Fair – evidence of moderate staining and deterioration to timber structure, particularly to the sarking boards. Undulating ridge line is evident externally.
17 The second se	Building 06, 07 - Roof Coverings & Rainwater Goods Description: Natural slate coverings, cast iron rooflights, galvanised steel ridges and hips. Internal guttering. Condition: Poor – slipped slates across majority of surfaces. Partially collapsed section of roof approx 5m2. Choked internal valley gutters. Corroded rooflight frames, cracked and missing rooflight glazing.

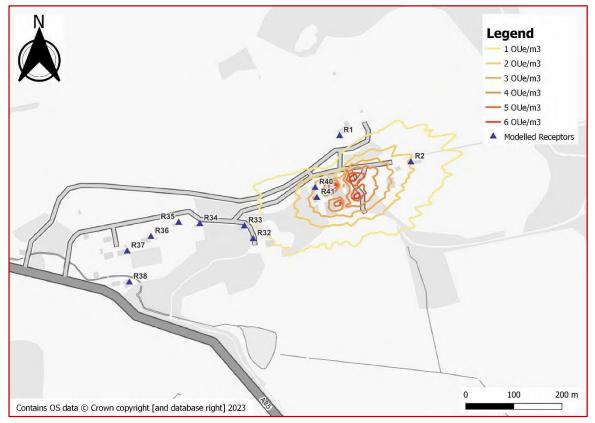
Figure 5-5 – Contour Plot of 98th Percentile 1-hour mean Odour Concentration 2021

No additional mitigation measures are required to ensure that surrounding sensitive receptors are not exposed to significant odour emissions given assumptions made regarding the two residential receptors around the site which are modelled to experience $3 \text{ OU}_{\text{E}}/\text{m}^3$ in a worst case scenario.

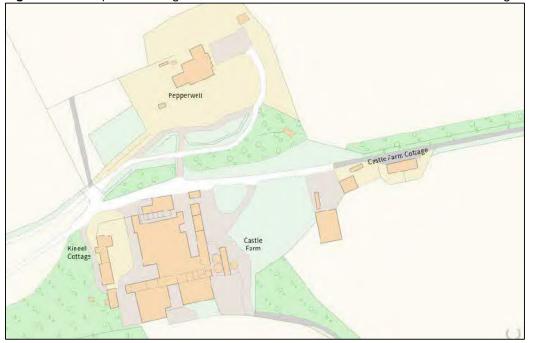
Figure 2.1: Site plan showing location of Castle Farm and nearest residential dwelling.

- 2.4 It is understood the new grain dryer will be silenced and the new system will be fully enclosed meaning the level of dust is greatly reduced. The current grain dryer is old and due to the large amounts of dust generated there were large extract fans installed. These were found to be the current dominant noise source, however, the new system will utilise much less powerful fans and should in theory be less noisy.
- 2.5 Existing ambient noise levels were measured at the nearest sensitive receptors in order to establish typical background noise levels. During our site visit it was noted that the noise is dominated by distant road traffic noise and bird song.
- 2.6 The grain dryer was switched on for the purpose of the noise assessment and it was found that the extract fans where the dominant noise source.

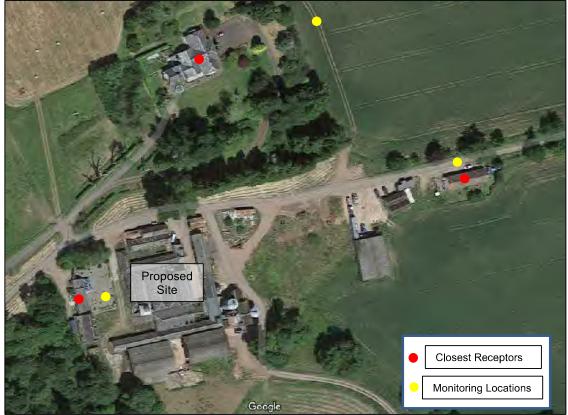
Figure 4.1: Background Monitoring Locations

- 4.2 Measurements were undertaken in free-field conditions with the sound level meter mounted 1.5m above local ground level. The weather was dry and clear with a no wind and considered conducive to environmental noise monitoring. Protective windshields were also fitted to the microphones.

- 4.3 The noise monitoring equipment was calibrated before and after the measurement surveys using an acoustic calibrator, which had itself been calibrated against a reference set traceable to National and International Standards. It is considered that no unusual events occurred during the survey periods and the measurement data are considered to be a true and a fair representation of the industrial and background noise levels. No significant drift in calibration level was observed.

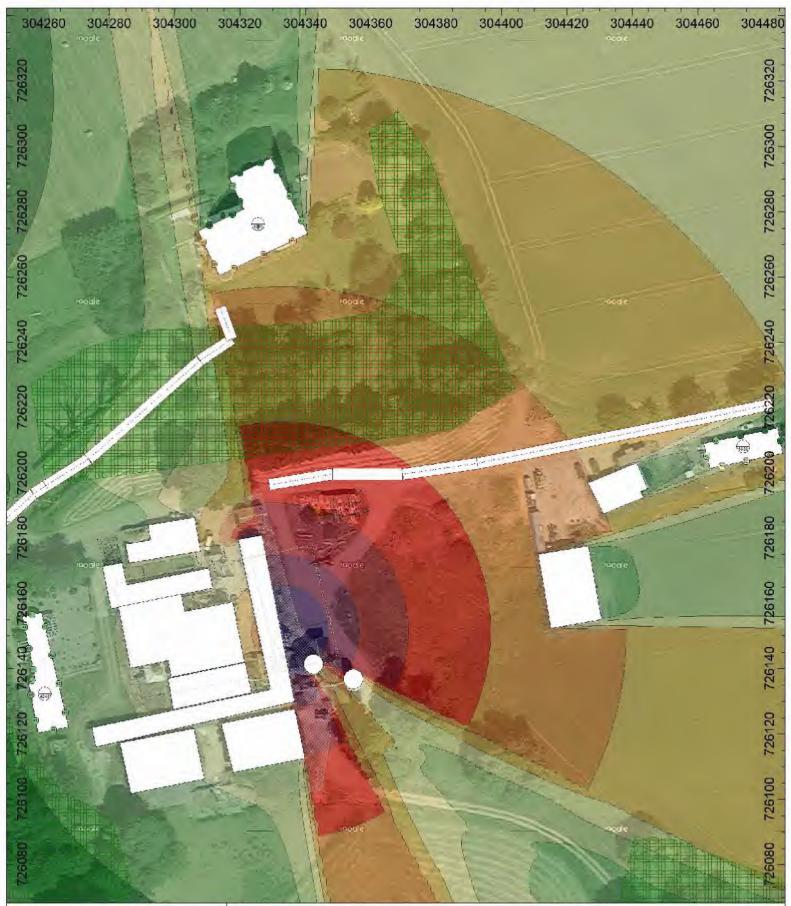
0 <= < 35 35 <= < 40	Project:	15827056 - Methven Castle Farm	
40 <= < 45	Description:	Noise Impact Assessment.	GAU VER
45 <= < 50 50 <= < 55	Condition:	Current Conditions	
55 <= < 60 60 <= < 65	Modelled:	N MacDonald	7828
65 <= < 70 70 <= < 75	Reviewed:	R Giudice	B U R E A U
75 <= < 80 80 <=	Date:	27.09.22

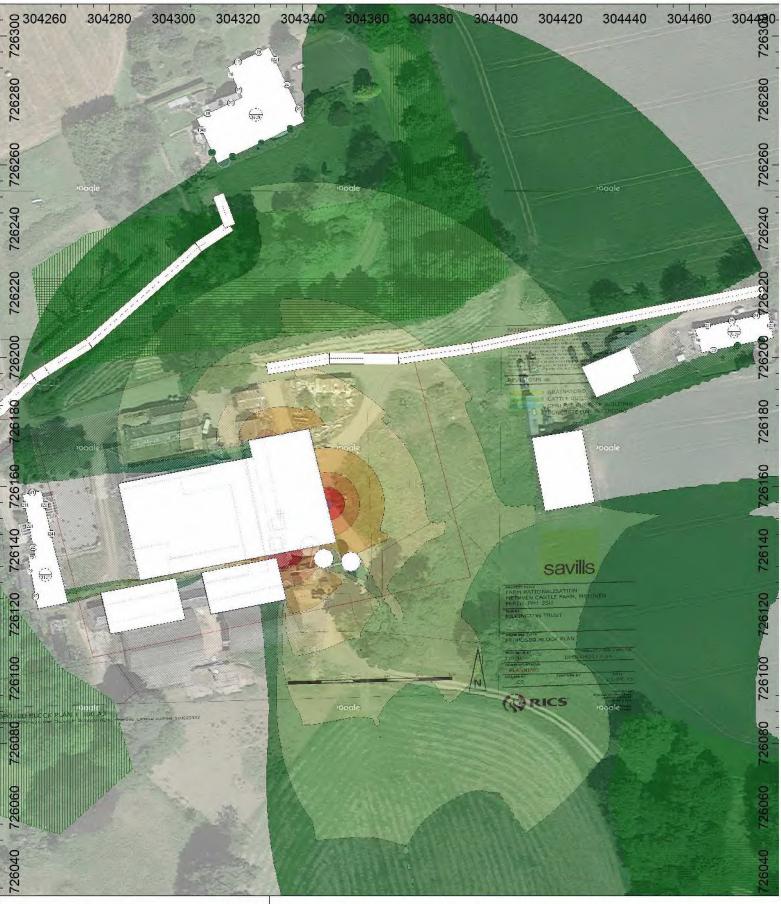
0 <= < 35	Project:	15827056 - Methven Castle Farm Noise Assessment V2	
35 <= < 40 40 <= < 45	Description:	New Grain Dryer - Day	AUVEN
45 <= < 50 50 <= < 55	Condition:	Proposed Dryer	
55 <= < 60 60 <= < 65 65 <= < 70	Modelled:	A Hussain	BUREAU
70 <= < 70 70 <= < 75 75 <= < 80	Reviewed:	N MacDonald	VERITAS
80 <=	Date:	16.08.23

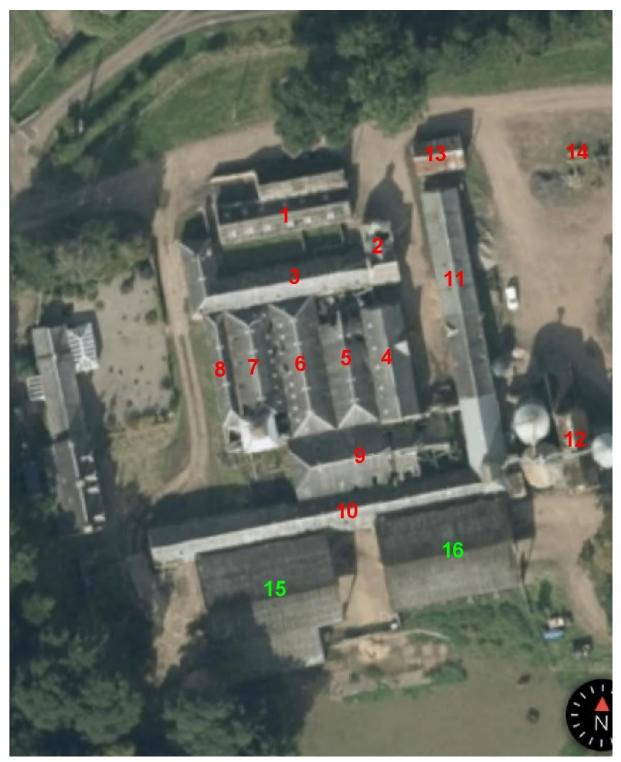
Figure 4 Aerial View showing Buildings 1-16

Methven Castle Farm Steading comprises a complex of several interconnected agricultural buildings within the Methven Castle Estate. The buildings are shown in Figure 3 Existing Site Plan and Figure 4 Aerial View. The buildings have been numbered 1-16 and include 14 buildings which are to be demolished or have collapsed, and 2 buildings to be retained. The majority of the buildings are traditional stone-built steading with slate rooves on timber sarking. There are 3 timber/part-timber structures to the north and 2 open barns to the south.

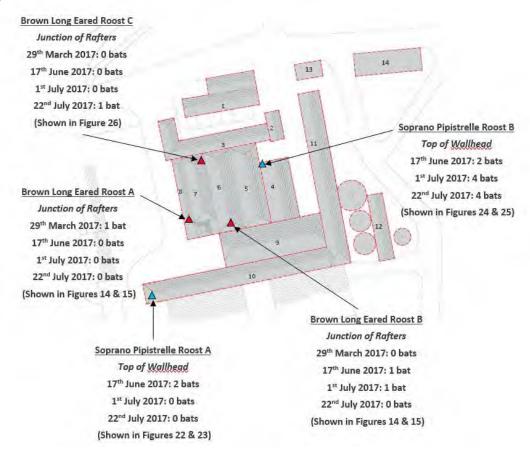
In 2017 Neo Environmental identified three Brown Long-eared bat roost locations each containing one Brown Long-eared bat were identified. These are shown on the plan below in Buildings 6, 7 and 8. Two Soprano pipistrelle roost locations containing a total of 6 Soprano pipistrelles were identified. These are shown on the plan below in Buildings 4 and 10. Figure 10 2017 Bat Roost Locations

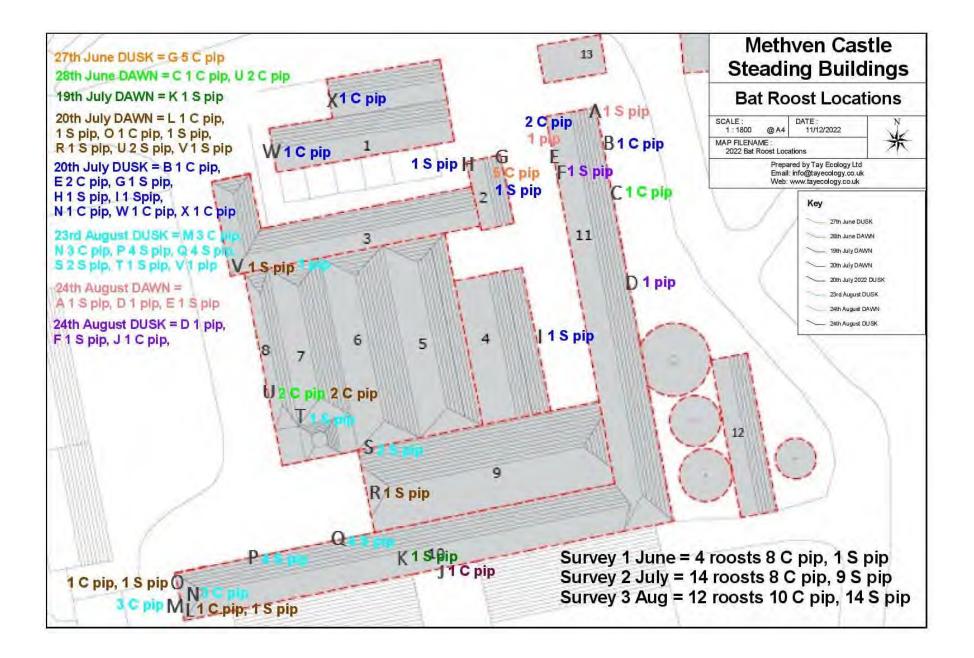
Figure 11 2022 Bat Roost Locations

Table 1 2022 Bat Roost Locations From Appendix A Neo Environmental Bat Survey Report Methven Castle Farm Steading.

Bat	Date	Dawn/	Build	Location	Number of
Roost		Dusk	ing		Bats
А	24/08/22	Dawn	11	Eaves of building below soffit.	1 Soprano pip
В	20/07/22	Dusk	11	Rightmost window on east side of building.	1 Common pip
С	28/06/22	Dawn	11	Collapsed roof tiling to left of broken window.	1 Common pip
D	24/08/22	Dusk	11	Emergence from broken window (top left panel).	1 Unknown
E	20/07/22 24/08/22	Dusk Dawn	11	Leftmost door of west side of building.	2 Common pip 1 pip sp.
F	24/08/22	Dusk	11	Gap below gutter.	1 Soprano pip
G	27/06/22 20/07/22	Dusk Dusk	2	Gap below tiling just below soffit at building eaves.	5 Common pip 1 Soprano pip
Н	20/07/22	Dusk	2	Gap below tiling just below soffit at building eaves.	1 Soprano pip
Ι	20/07/22	Dusk	4	Apex of gable end.	1 Soprano pip
J	24/08/22	Dusk	10	Broken window in roof.	1 Common pip
Κ	19/07/22	Dusk	10	Gap in tiles 80% of way up to roof apex.	1 Common pip
L	20/07/22	Dawn	10	Gap between barge board and tiling, halfway to gable apex.	1 Common pip 1 Soprano pip

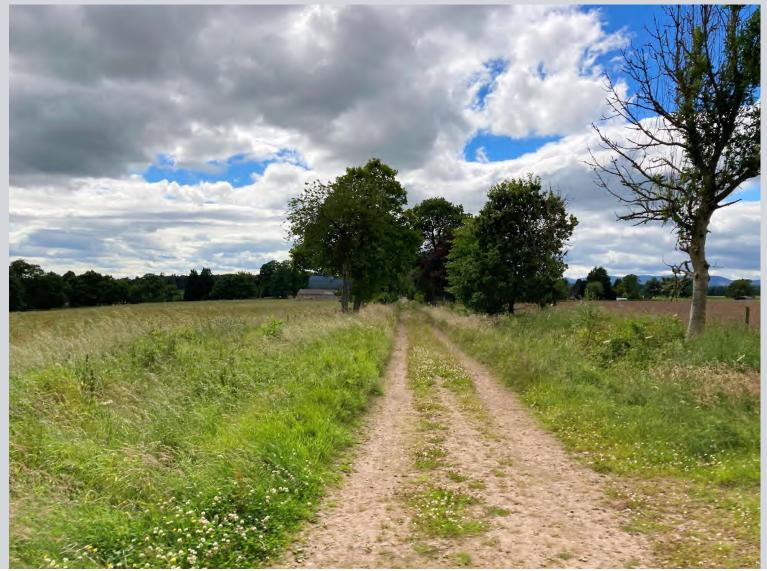
View of Proposal from Core Path (3D visualisation)

The 3D visualisations submitted with the proposal demonstrate that the majority of the sheds are hidden from three public viewpoints due to landform, topography and existing natural features, such as trees. Those passing on the A85 will only have a very small and quick view of the buildings.

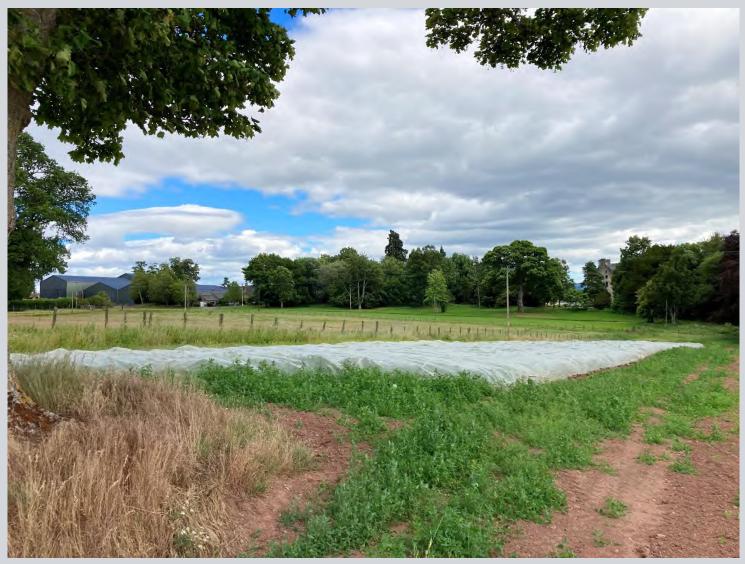
View of Proposal from Access Track (3D visualisation)

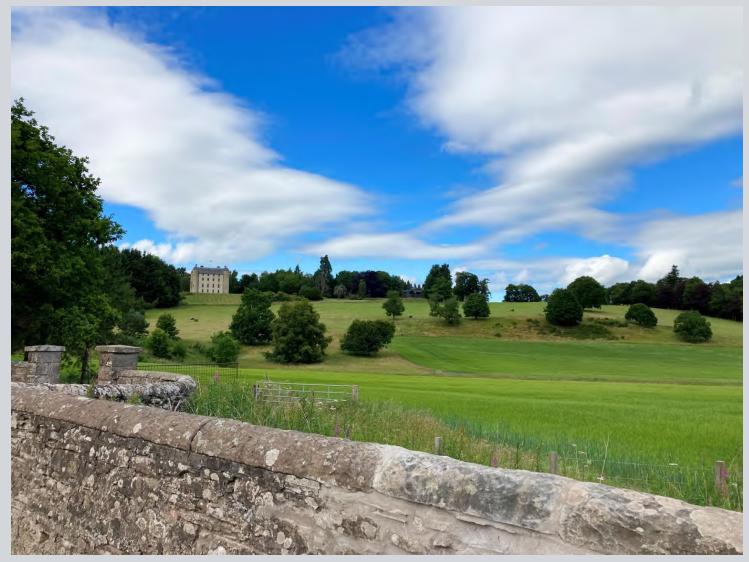
View of Proposal from A85 (3D visualisation)

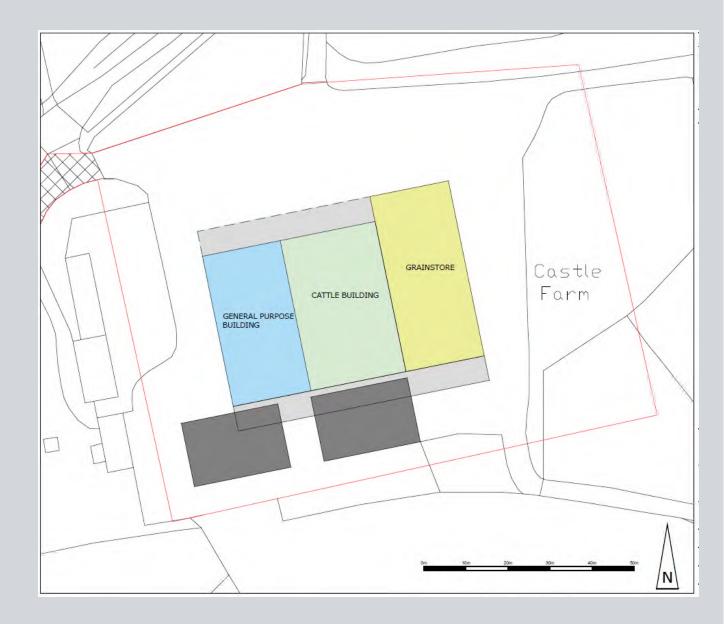
The image shows the proposed layout of the new sheds, including the grainstore (yellow), cattle building (green) and general purpose building (blue). The two grey buildings to the south are existing sheds to be retained.

The new sheds will connect into the existing water and electricity supply.

The proposed grain store is approximately $36m \times 19m$, the proposed cattle shed is approximately $36m \times 23m$ and the proposed general purpose shed is approximately $36m \times 18m$.

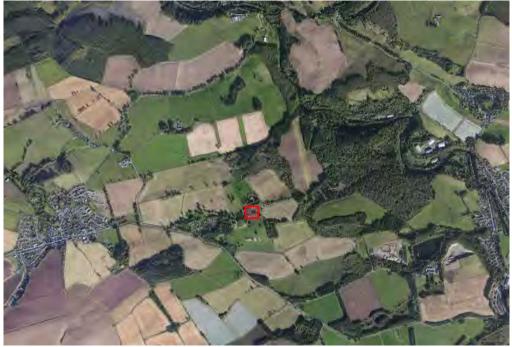
Figure 1. Aerial photograph of Methven Castle Farm Steading and wider environs. The developmental boundary is outlined in red and the site is shown in more detail in Figure 3.

Methven Castle Farm Steading comprises a complex of several interconnected agricultural buildings within the Methven Castle Estate (see Figures 1-3). The Estate is located approximately 10.5km west of Perth and just over 2km east of Methven village. It is bounded to the south by the main A85 to Perth, and to the north and east by the steep valley of the River Almond. The abundance of mature broadleaved woodland in the immediate vicinity of the steading offers excellent foraging and commuting habitat for bat species (particularly obligate edge foragers such as *Pipistrelle spp*). In particular the riparian woodland along Methven Loch and the River Almond (approximately 700m to the east and 800m to the northeast respectively) offers ideal foraging habitat for bats. Riparian woodland is typically replete with insects and as such is a key habitat for many bat species. *Pipistrellus pipistrellus, Pipistrellus pygmaeus* and *Myotis daubentonii* show a clear preference for this type of foraging habitat and the mixture of water, woodland, open areas and edge habitat, in the immediate vicinity of the proposed development site offers ideal foraging habitat for all of Scotland's resident bat species.

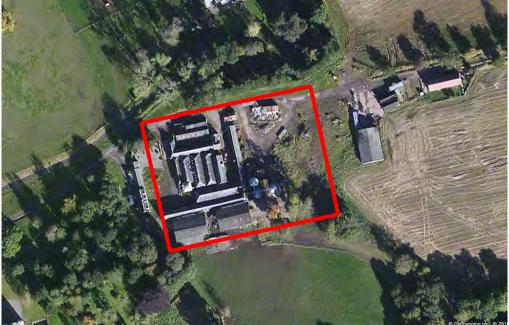
Figure 2. Aerial photograph of Methven Castle Farm Steading. A developmental boundary for indicative purposes only is outlined in red. The buildings scheduled to be demolished have been labelled 1-14 in Figure 3.

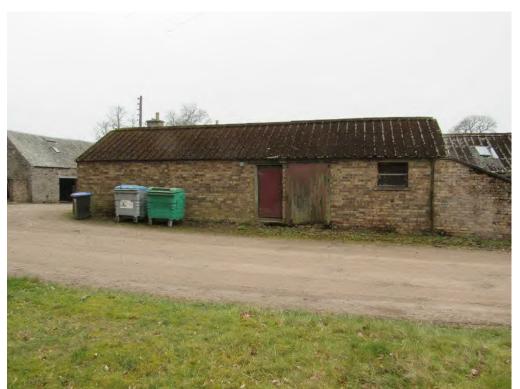
Building one is a single storied, red brick shed with a pitched roof lined with corrugated asbestos roofing sheets (Figure 4). The building is in poor to reasonable condition and is currently being used for storage. The southern section is a disused stable block. Gaps are present around eaves, but the roof leaks and sunlight can enter the stable area. Extensive cobwebs throughout. The red brick exterior and the roofing sheets are loosely fitted around the eaves leaving no crevice habitat that could provide potential roost sites. Buildings lined with this type of asbestos cement roofing sheets typically provide suboptimal roosting habitat for bat species and despite a thorough inspection there was no evidence that bats have ever occupied this building.

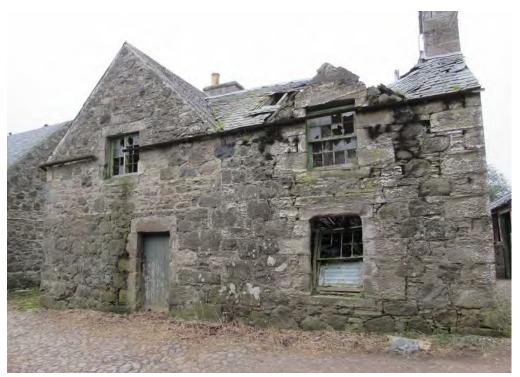
Building two is a large, two storied, stone-built structure with coursed rubble walls and dressed stone around doors and windows (Figure 5). The northern section of the roof is pitched and lined

- Washed out mortar along the eaves providing access to the space above the wallhead.
- Large gaps beneath the flashing along the ridge and the uncapped gable ends.
- Numerous openings across the roof providing access to the space between slates and sarking.

Despite the presence of potential roost sites there was no evidence to indicate that bats have ever occupied this building, with many features being cobwebbed over. However, despite the lack of evidence the possibility of small numbers of crevice dwelling bat species roosting beneath the roof coverings cannot be ruled out.

Figure 5. Building 2 – eastern elevation.

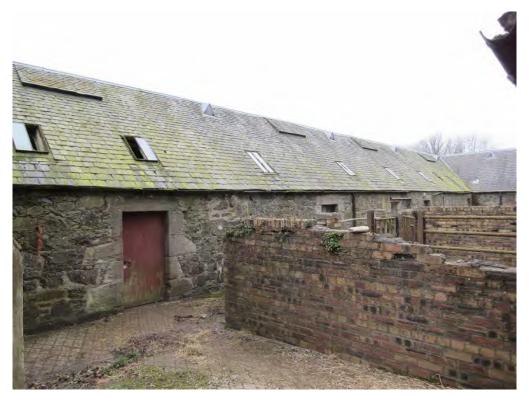
Building three is a stone built (random rubble) structure with a pitched roof lined with grey slate (Figure 6). The majority of the building is single storied comprising open sheds used to house cattle. However, there is a small two storied section on the western elevation that could not be

accessed during the current survey (see APPENDIX 3 for location) due to health and safety concerns. The building is in reasonable condition; however, potential roost sites were identified where washed-out mortar has resulted in crevice habitat along the eaves and there are numerous areas of the roof where raised flashing and missing slates provide access to potential roost sites. Internally the building is open to the roof, collar beamed and lined with wooden sarking. Within the building, several nests belonging to swallows and wasps and a feral pigeon roost were noted. Despite a thorough inspection, with the aid of a flexible endoscope, there was no evidence either internally or externally to indicate that bats have ever been in occupation.

Figure 6. Building 3 – northern elevation.

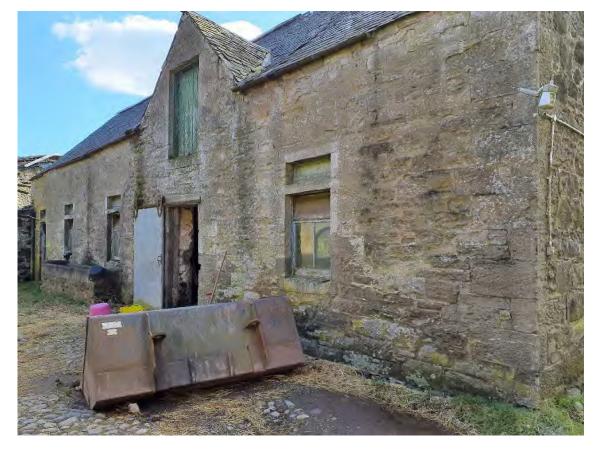
Building four is a large, two storied, stone-built structure with coursed rubble walls and dressed stone around doors and windows (Figure 7). The roof is pitched and lined with grey slate. The building is in poor condition and large cracks in the external stonework, uncapped flashing and missing slates all provide potential roost sites. Internally the ground floor currently functions as a stable with heavy cobwebbing on the ceiling. The first floor is open to the roof internally collar beamed and lined with wooden sarking (Figure 8), but safety concerns prevented an inspection to the level it was performed in 2017. However, no evidence was found either internally or externally that would indicate the presence of bats.

Figure 7. Building 4 – eastern elevation.

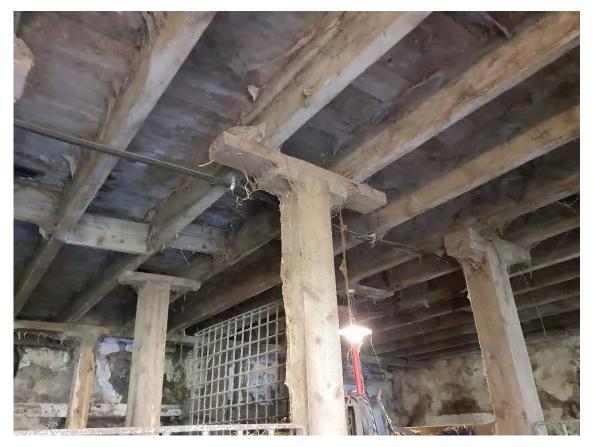
Figure 8. Building 4 shows heavy cobwebbing on vast majority of the ceiling.

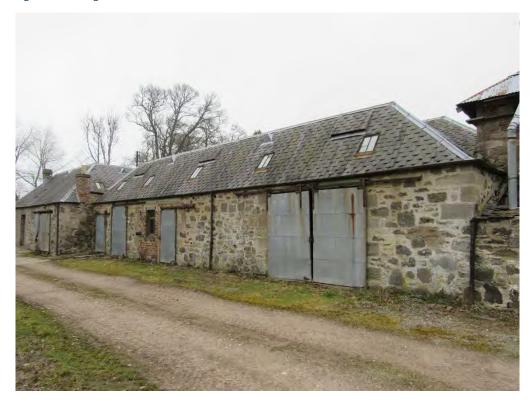
Buildings 5-8 comprise four large barns of similar construction. These are all old milking barns which are single storied, stone built barns with pitched roofs lined with grey slate (see Figure 9 for example). Building 5 has completely collapsed (Figure 10) but all other buildings are intact. As with the other buildings within the steading there are an abundance of potential roost sites on the external fabric of the building with numerous large openings along the eaves and an abundance of gaps beneath slates and flashing. Internally the barns are open to the roof and lined with wooden sarking (Figure 11. Following a thorough inspection, a small pile of droppings were found on the floor on the southern end of building 6. It is possible that these droppings are from previously identified roosts in 2017. In addition, approximately 8 droppings were found on wall below unpolished rafters on the northern end of building 6 (Figure 12). The shiny and granulated appearance of the droppings were indicative of brown long eared bats. However, the vast majority of the droppings were old and discoloured (<2yrs old) and the number and condition of the droppings is typical of a roost site used by small numbers or solitary bats over a long period of time. Due to dropping location, it was not possible to collect a sample safely without compromising the quality of the sample. Furthermore, a rafter on the northern end of building 7 contains one polished area (Figure 13).

Figure 9. Building 8 – western elevation.

The buildings were fully inspected on two separate occasions due to the historic presence of roosts in these buildings (see Table 1 for timing) and on each occasion no bats were present in any building.

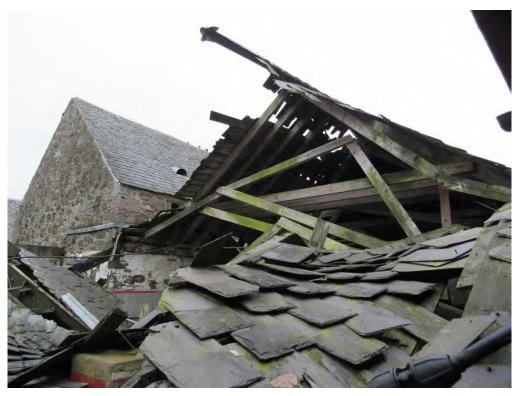
Figure 10. Building five has completely collapsed and no safe access was possible.

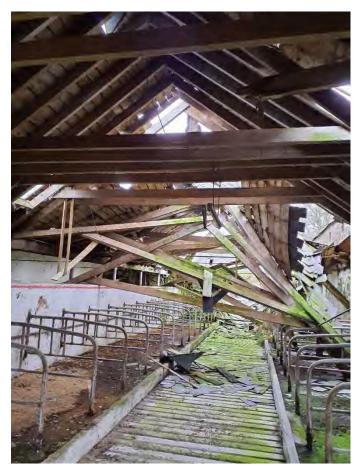
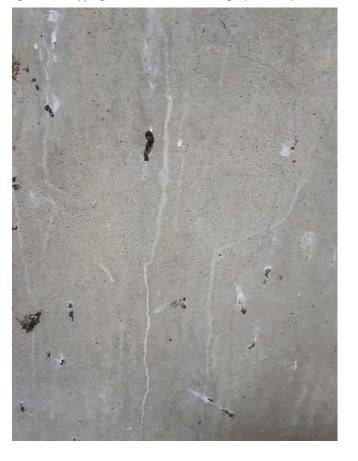
Figure 12. Droppings found on wall of Building 6 potentially indicative of brown long eared bat presence.

Figure 13. Polished area of rafters in Building 7.

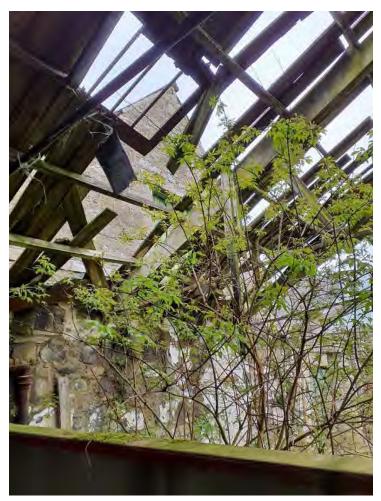
Building nine is a large single storied stone barn with a pitched roof lined with grey slate. There are small gaps in the lead flashing which could be used as roost features. The building is in extremely poor condition and the eastern section is in a state of partial collapse (Figure 14). There was no evidence to indicate that bats have ever roosted within this building.

Figure 14. Building 9 – eastern elevation.

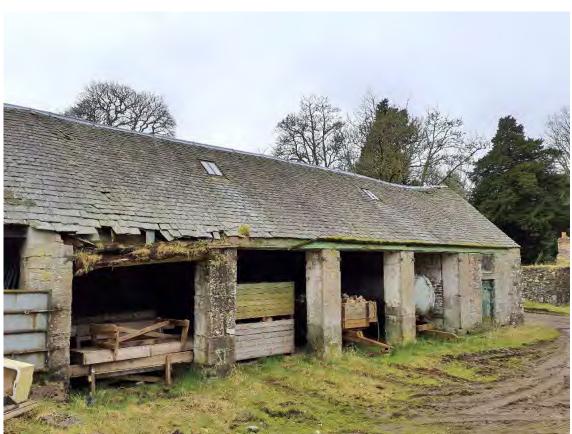
Building 10 comprises a number of discrete rooms forming the southern range of the steading. The entire structure is stone built (random rubble) with a pitched roof lined with grey slate. The vast majority of the building is single storied and open to the roof internally. However, there is a small two storied section on the very western end of the building. The two storied section is in extremely poor condition with a collapsed ceiling and a roof that appears extremely unstable. Therefore, it was not possible to enter this area safely. There are an abundance of potential roost sites across the building including

- Washed out mortar along the eaves providing access to the space above the wallhead.
- Large gaps beneath the flashing along the ridge and the uncapped gable ends.
- Numerous openings across the roof providing access to the space between slates and sarking.

However, despite the presence of potential roost sites there was no evidence to indicate that bats have ever roosted within this building.

Figure 15. Building 10 – northern elevation.

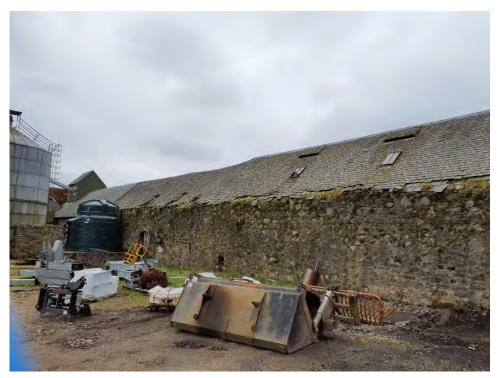
Figure 16. Building 11 – eastern elevation.

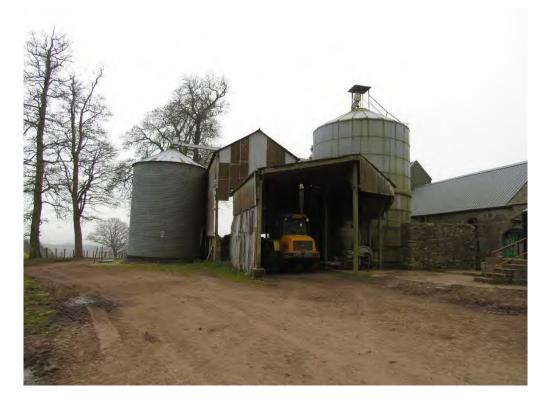
Building twelve comprises a large single skinned pole barn lined with corrugated metal sheets and four large metallic grain bins. Neither the barn nor the bins present any potential roost sites for bat species, and all are considered wholly unsuitable for roosting bats.

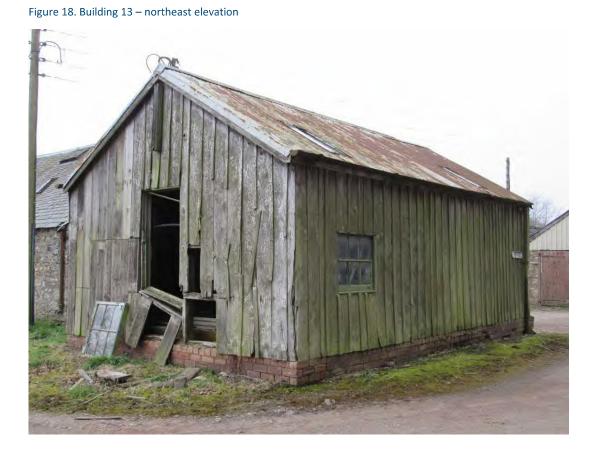
Building thirteen is a small single skinned wooden shed with a pitched roof lined with corrugated metal roofing sheets. The single skinned wooden walls and metal roof leaves no crevice habitat that could be exploited by bats. However, crevices in roof beams provide a low level of bat roost potential (see figure 20).

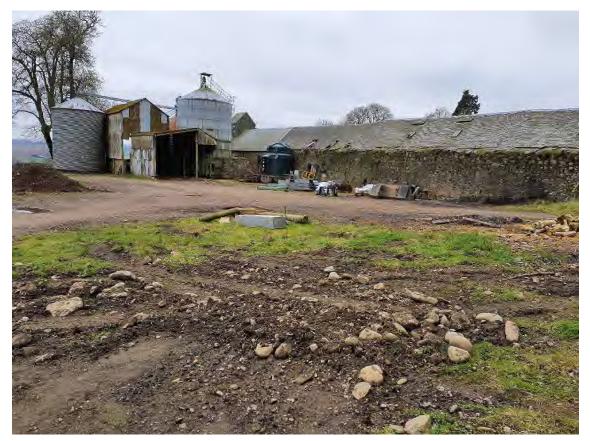
Building fourteen was a single skinned pole barn lined with corrugated metal sheets. However, the building has completely collapsed and now comprises of rubble recognizing and bare ground, and short ruderal to semi-improved grassland with no bat roost potential.

Figure 19. Prior site of Building 14.

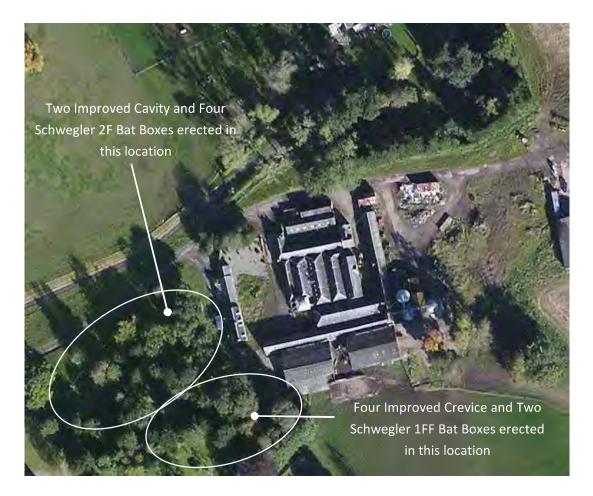
Site layout as proposed showing location of Mitigation:
