PERTH AND KINROSS COUNCIL**Environment Committee****12 November 2014****Blairgowrie, Oakbank Road Landslip****Report by the Executive Director (Environment)****PURPOSE OF REPORT**

Landslip Options Report

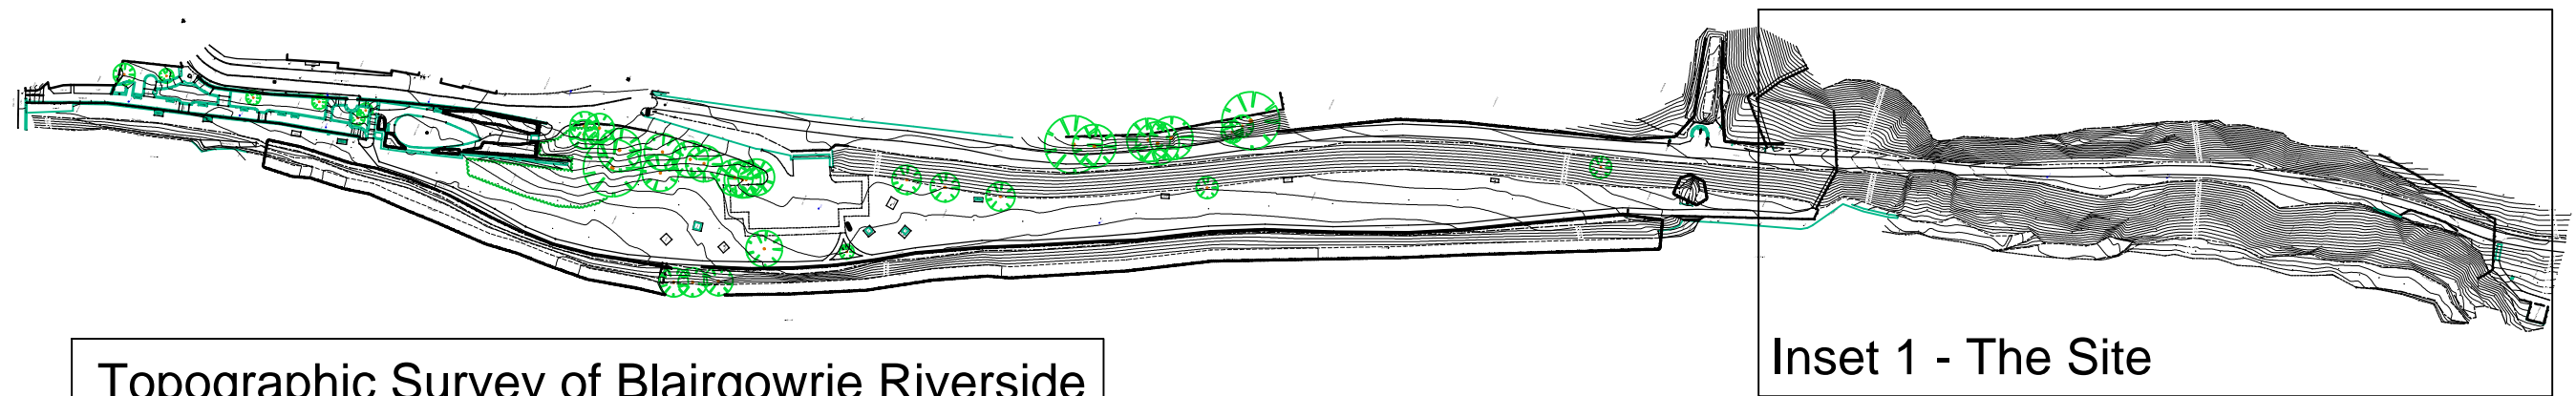
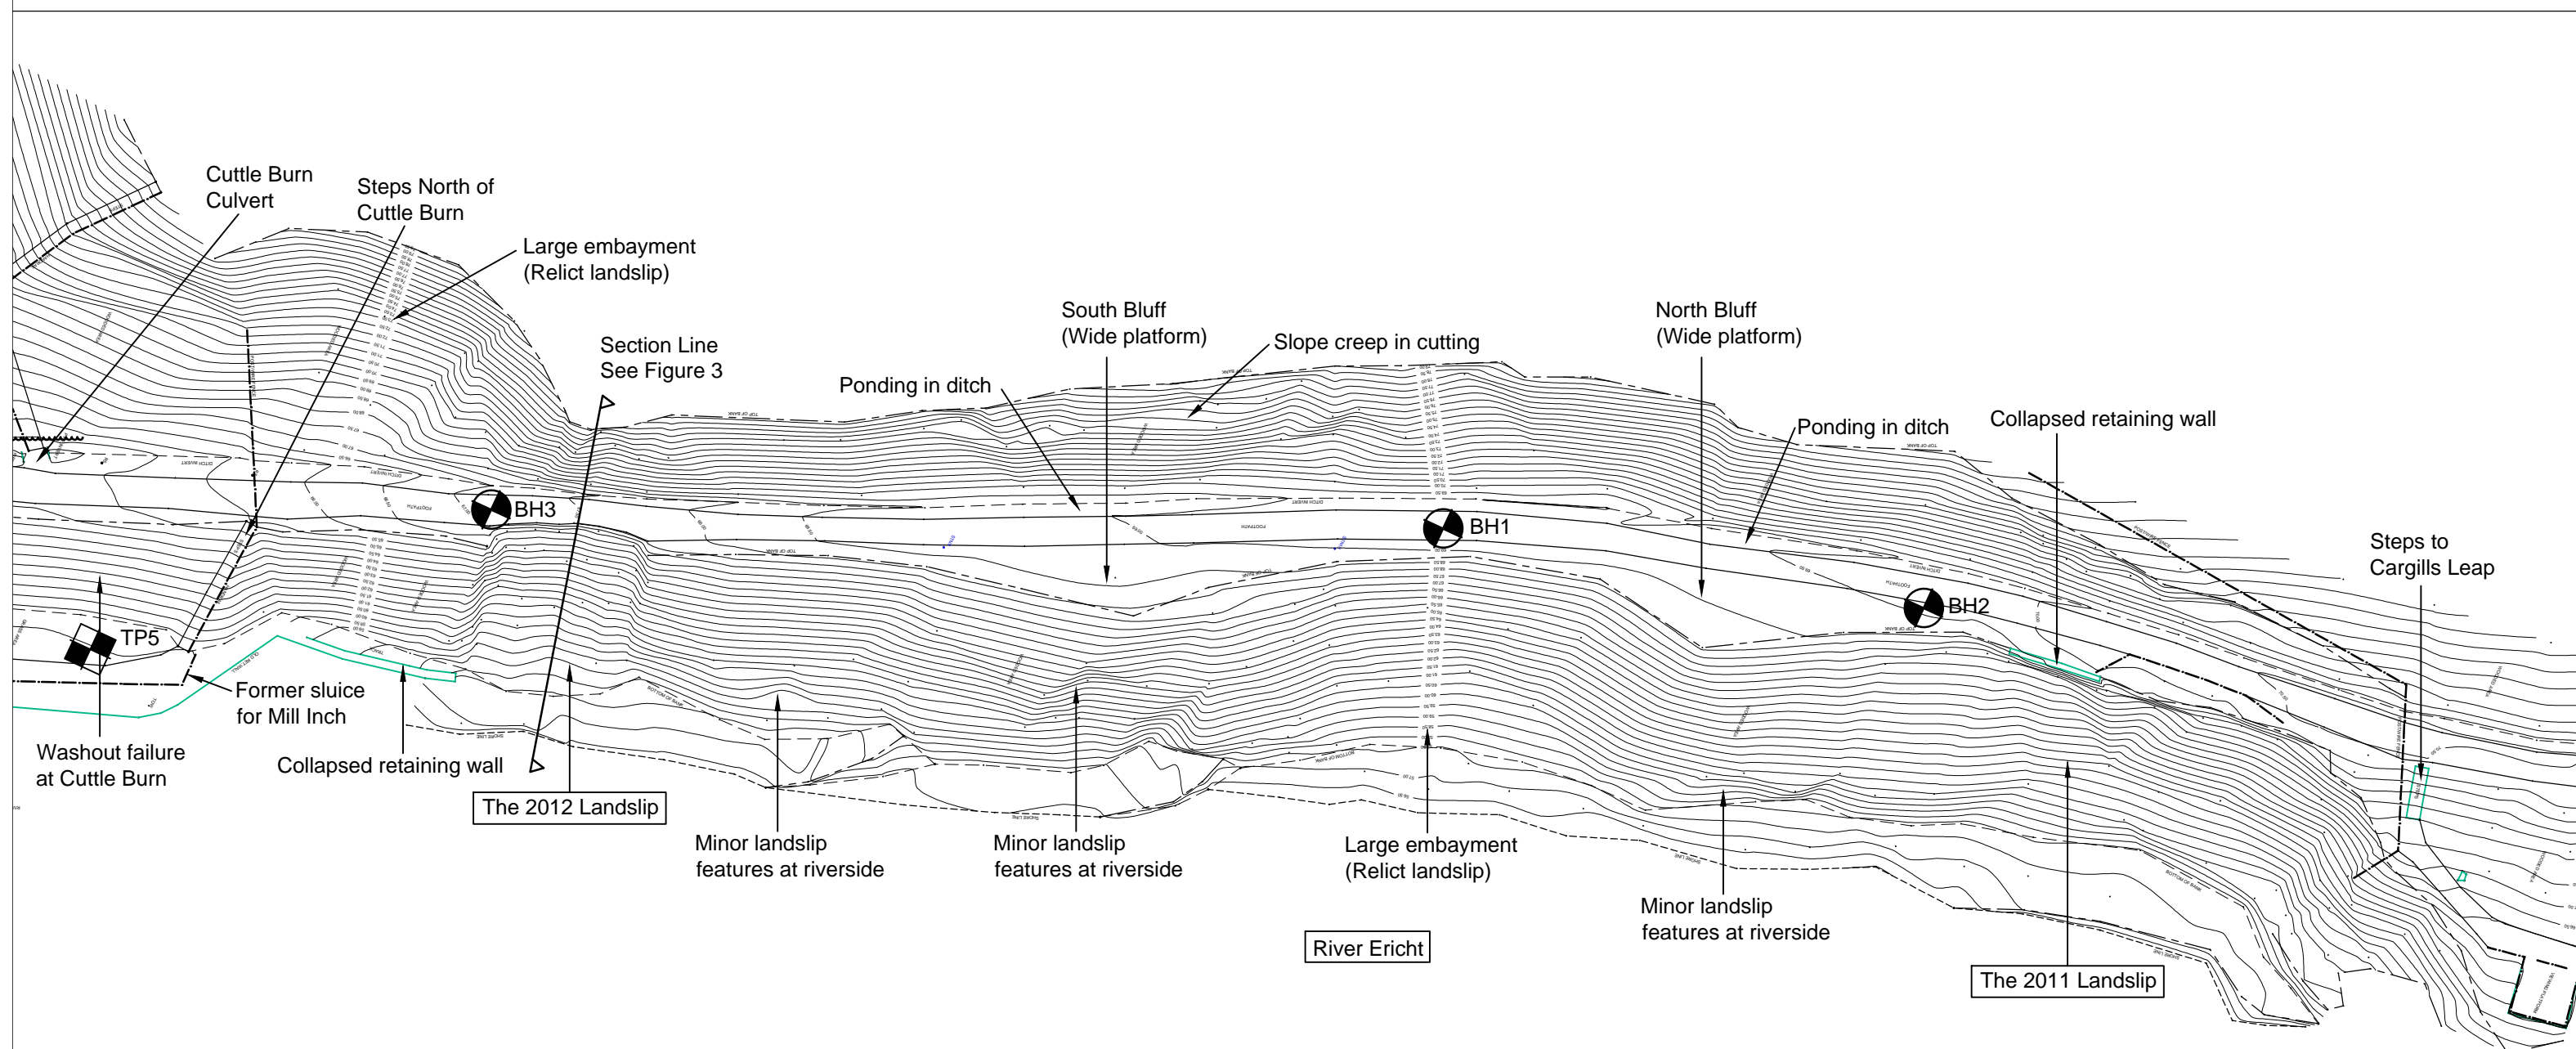
Figure 2 - Observed Landslip Features

Numerous areas of slope creep and landslip are evident on the steep flanks of this river terrace between Cargills Leap and Cuttle Burn. The main features are located on Figure 2 and these are summarised below:

The Slope between the two identified landslips can be characterised as two bluffs (north and south) and a large embayment between them (see Figure 2). The north bluff presents a relatively wide platform alongside the track and a heavily vegetated steep face directly above the river. The toe of this slope is over-steep due to erosion by the river and will have only marginal stability. The large embayment between the two bluffs also presents a heavily vegetated steep upper slope at 1 in 1.3 (37°), but this is offset from the river behind a lower slope of lesser gradient, being 1 in 2 (26°). It can be conjectured that this feature represents a relic landslip with debris removed by the river. Borehole 1 was located on the road to investigate ground conditions. The south bluff also presents a relatively wide platform alongside the track and a

Both of the above indicate the susceptibility of material to erosion and landslip on wetting up. Numerous areas of slope creep and landslip are also evident on the steep slopes above the road between Cargills Leap and Cuttle Burn. The main features are identified on Figure 2 and summarised below:
